FIRE ENDURANCE TESTS OF EXTERIOR WALL AND ROOF/CEILING CONSTRUCTIONS FOR SINGLE FAMILY HOUSE

NBS REPORT

10 406

Prepared for:
Department of Housing and Urban Development

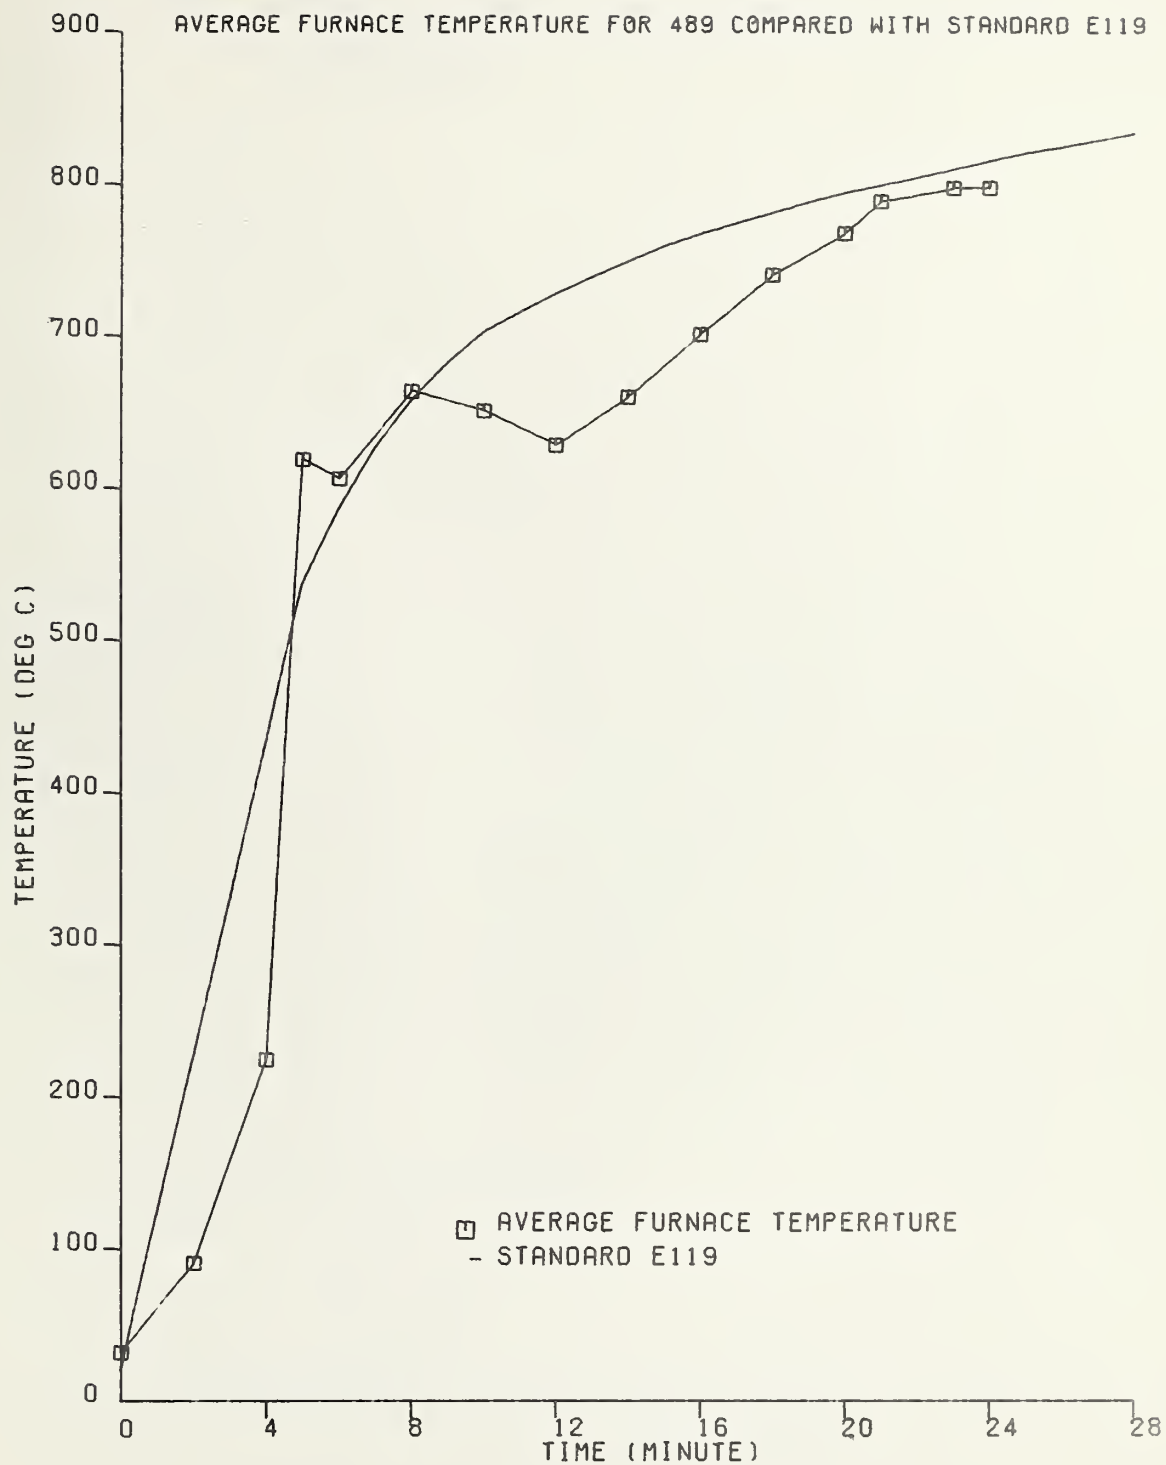
Figure 4

A log of the test observations is given in Appendix 1. The failure of the panel due to an average temperature rise of 139 C above its initial temperature on the unexposed surface was observed at 9 minutes. (See figure 4). The corrected time of failure, according to the standard correction formula in ASTM E119-69 based on the comparison of areas under the actual time-temperature curve and the standard curve, was 8 min: 20 sec. Load failure due to inability to maintain the load occurred at 23 min., and was followed by flame through at 26 min. on the south most joint.

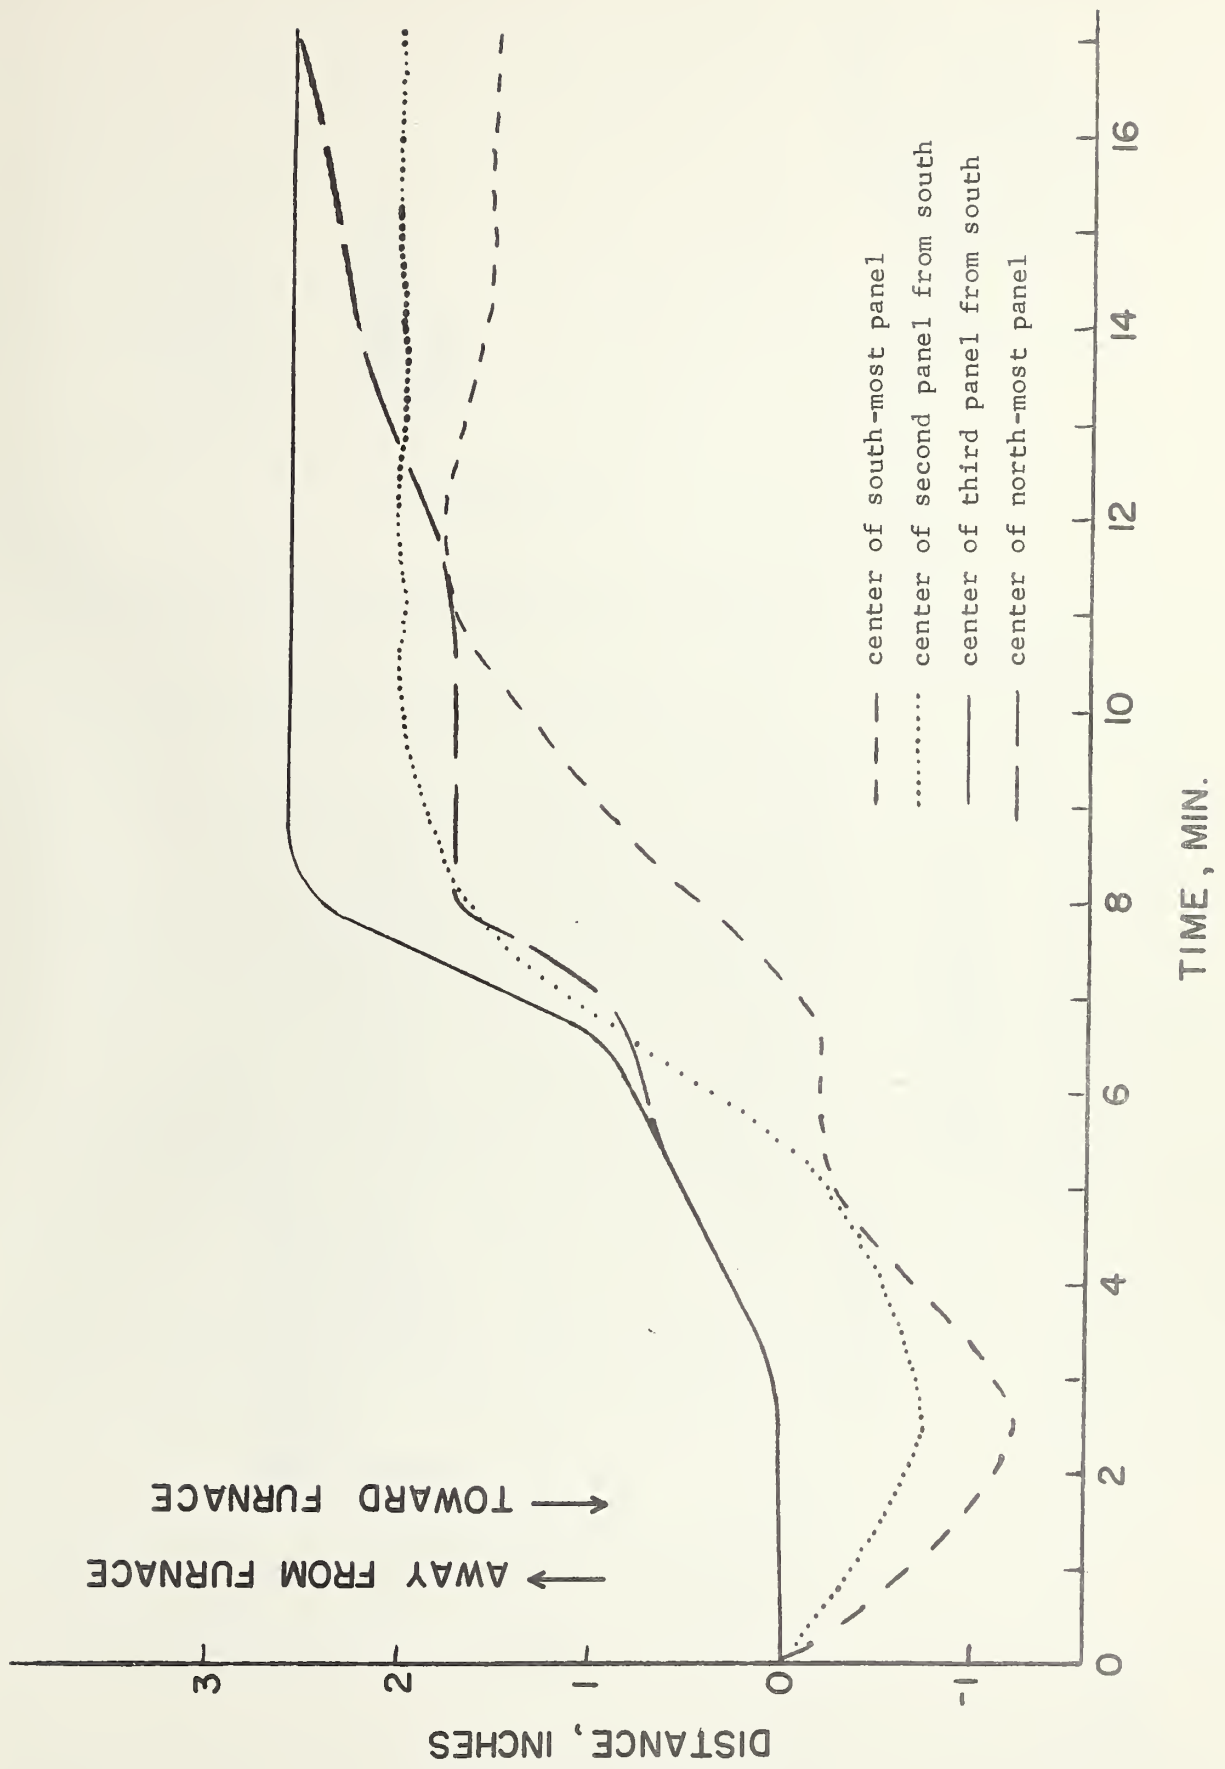
Deflections of the unexposed surface varied from 1-1/4" (toward furnace) to 2-1/2" (away from the furnace) and is shown in figure 7.

Figure 7 - deflections of the 4 points on the unexposed surface.

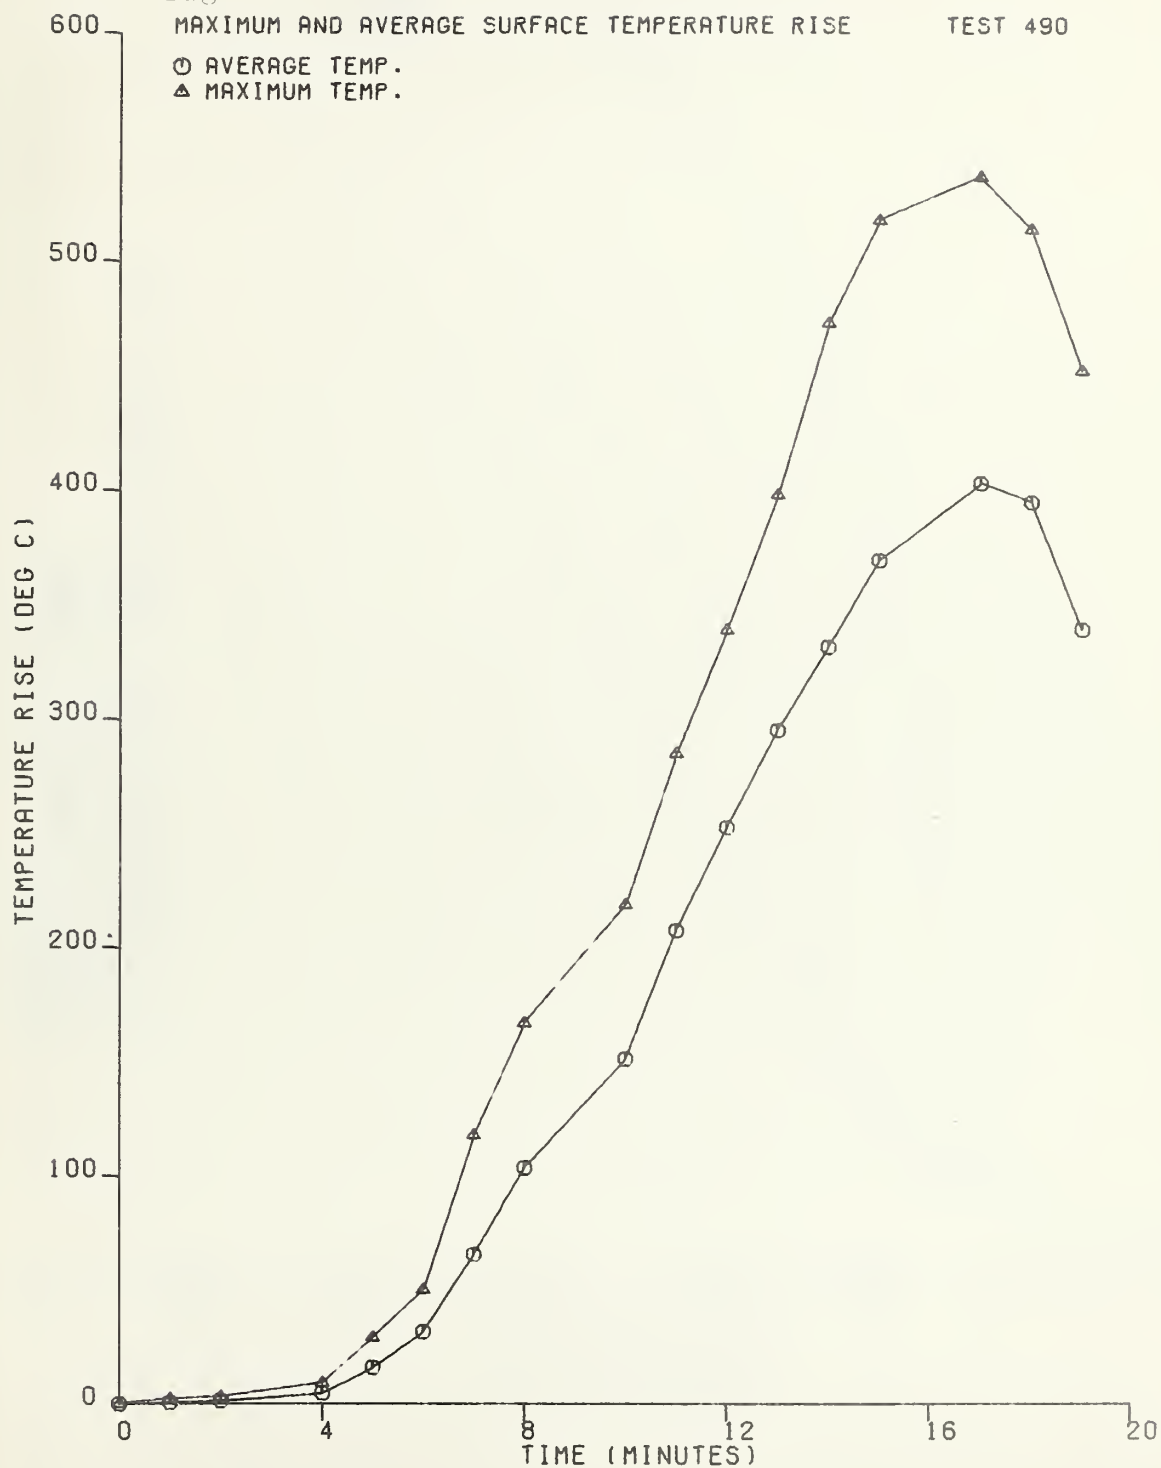
Figure 10

A complete log of the test observations is given in the Appendix I. The failure of the panel due to an average temperature rise of 139°C above its initial temperature on the unexposed surface was observed at 9 min:30 sec. as shown in figure 10. The corrected time of failure in accordance with the formula given in ASTM E119-69 was 10 min:09 sec.

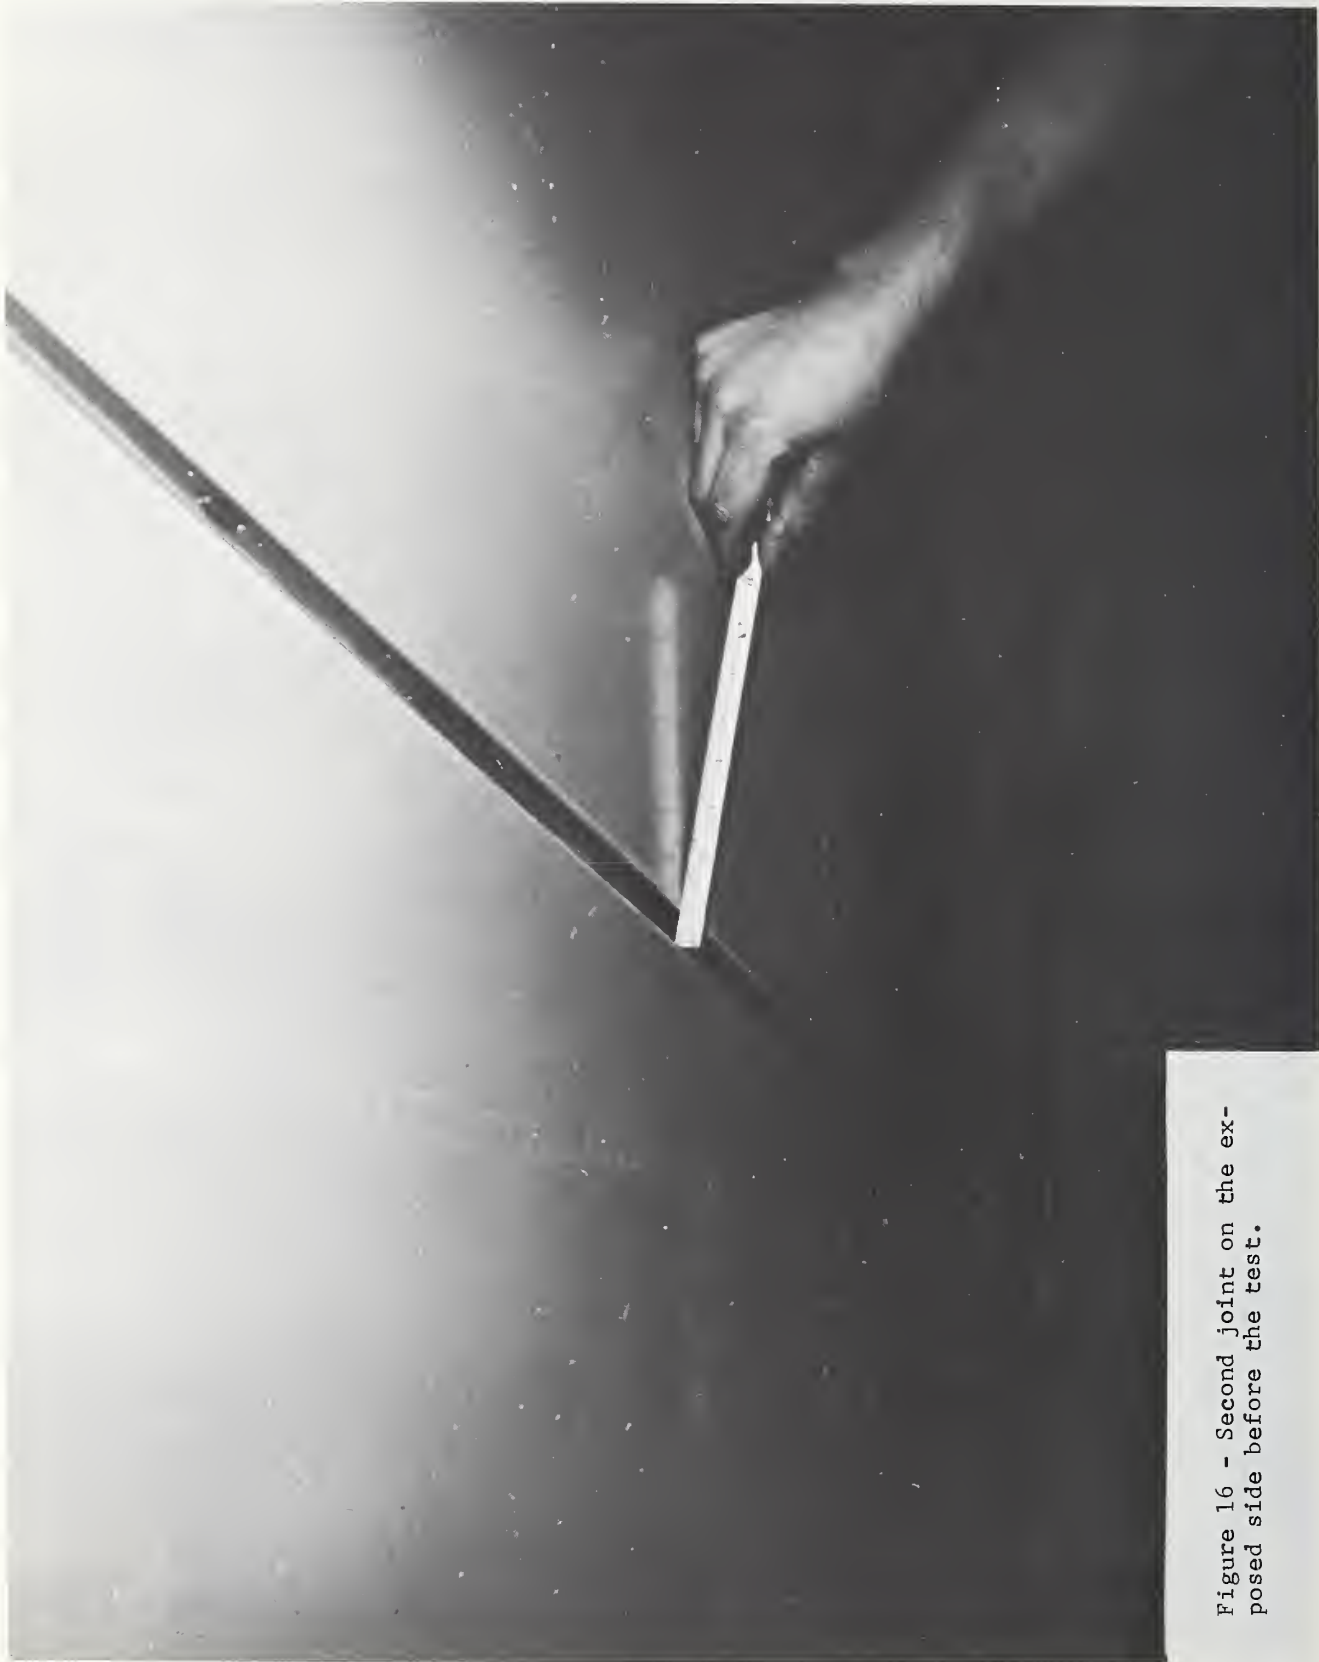
Figure 16 - Second joint on the exposed side before the test.
